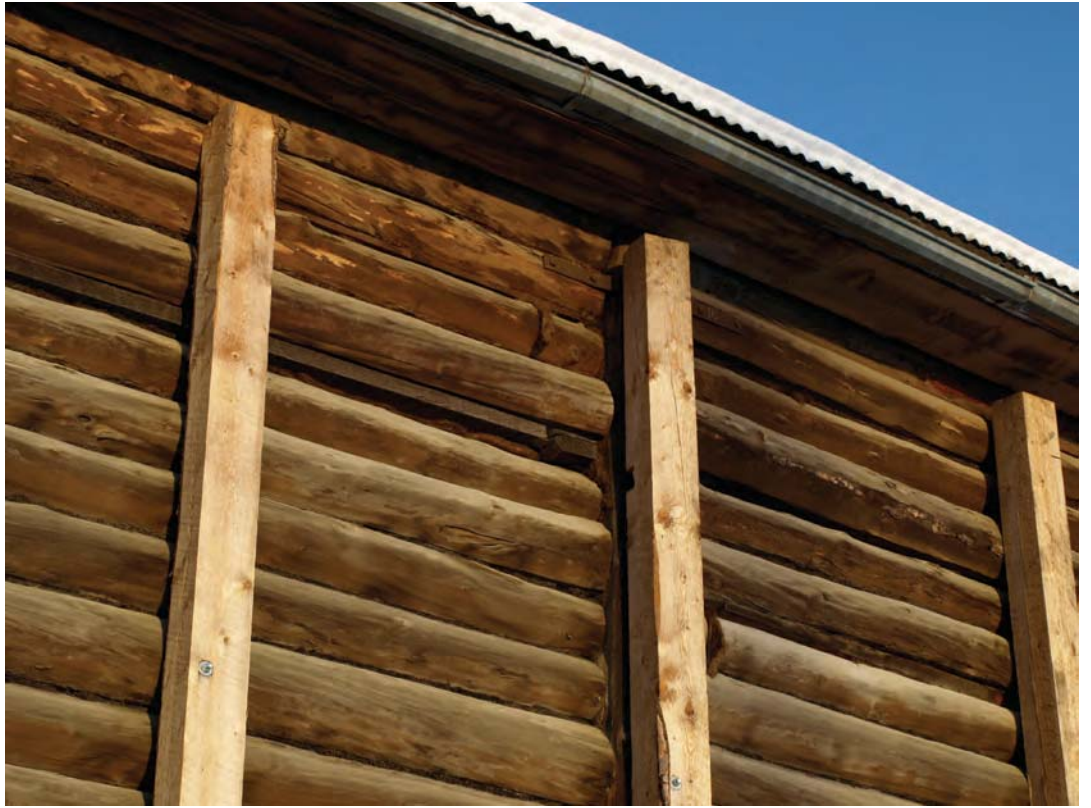
9. east wall, detail at center post

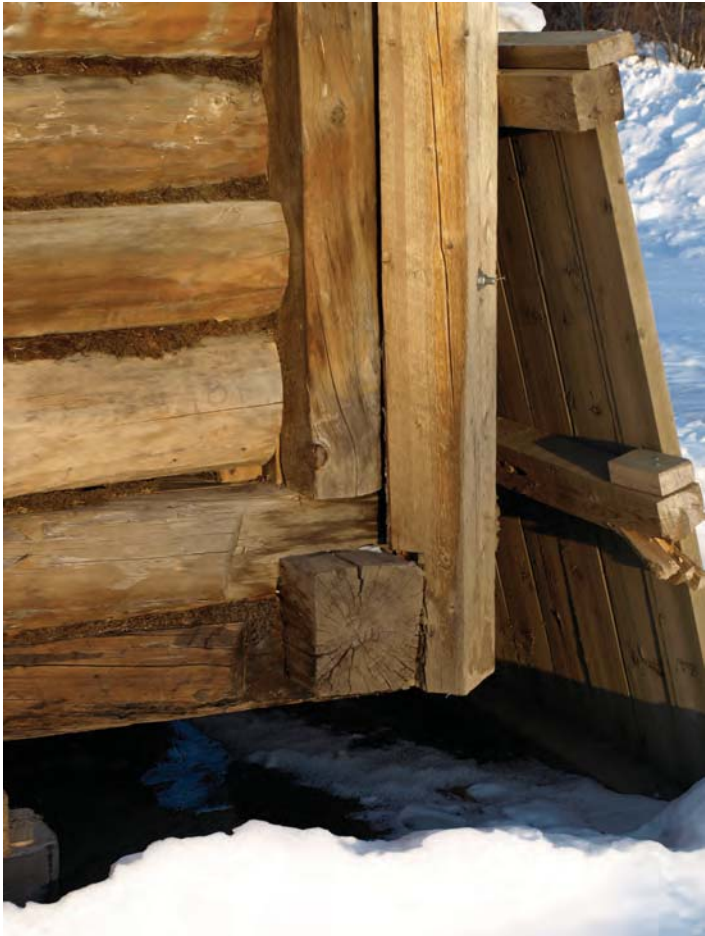
10. east wall, detail at rear corner; the lapped sill log is typical
