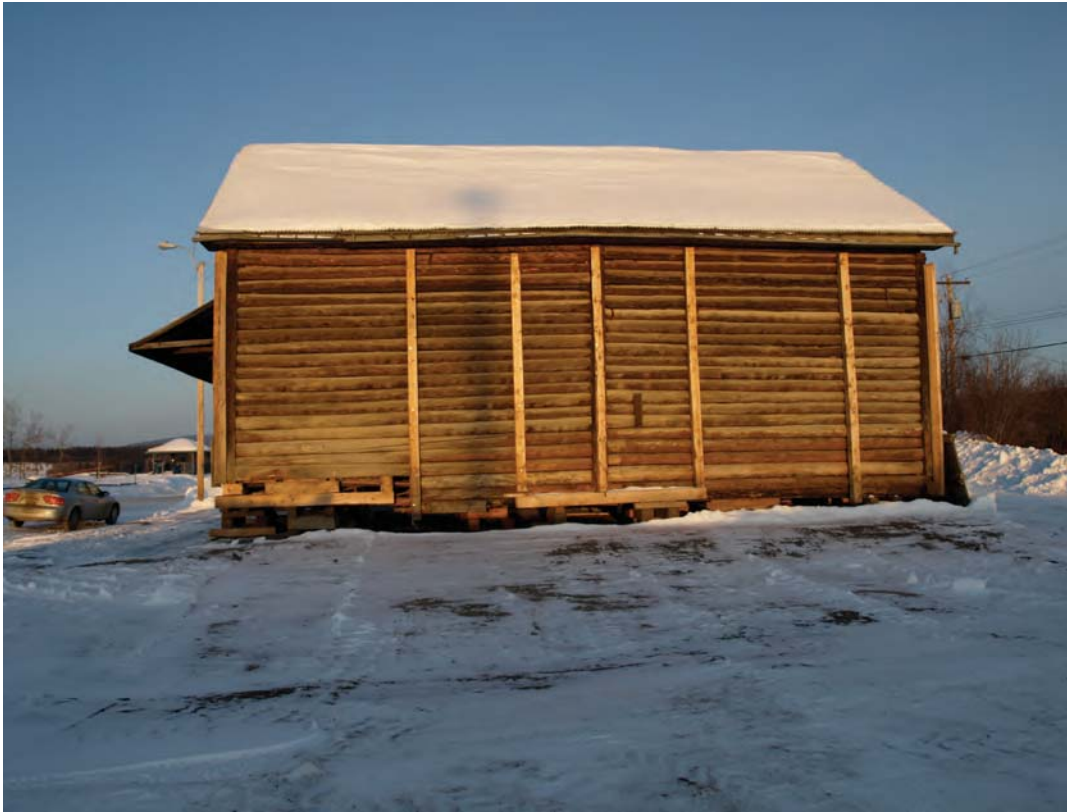
7. east wall: the building is supported with a series of strongbacks. The one in the middle of the wall is located on the mid wall vertical log

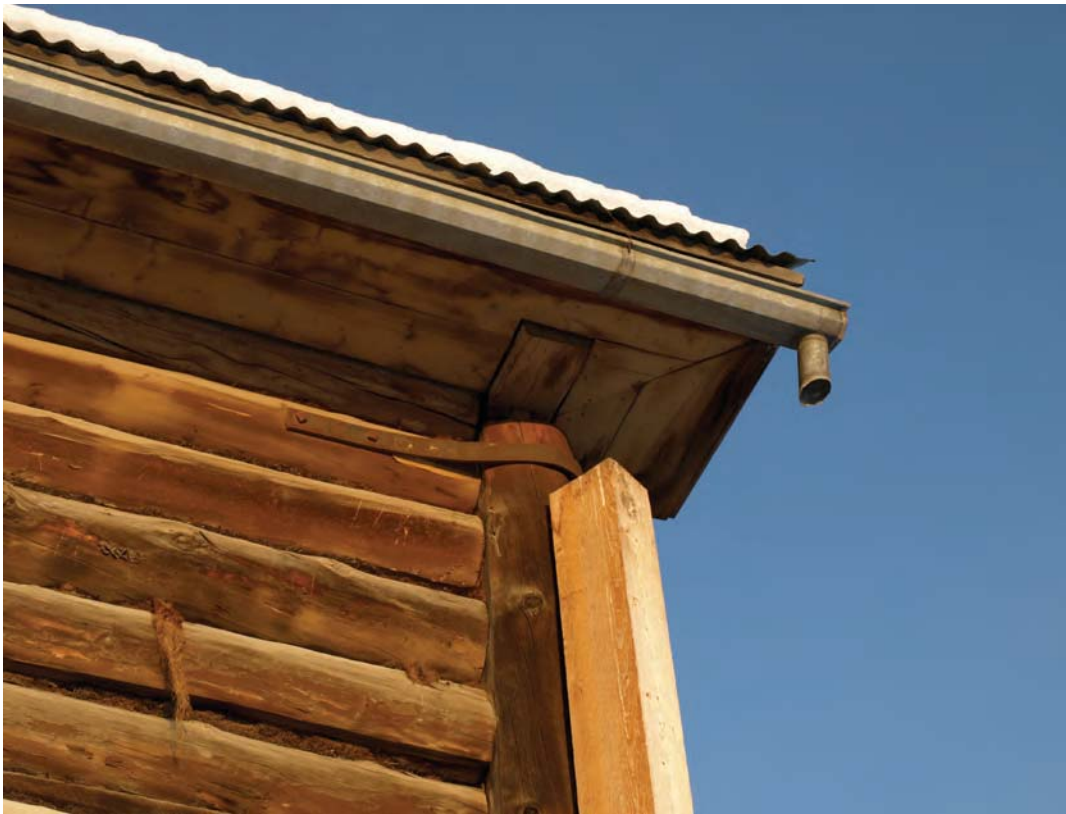
8. east wall, detail of upper rear corner, showing the typical steel strap and galvanized gutter. The squared log which is fitted into the soffit shows clearly
