# Behind the Headlines of the Eagle Gold Mine Crisis

Eagle Gold Mine remains a crisis.

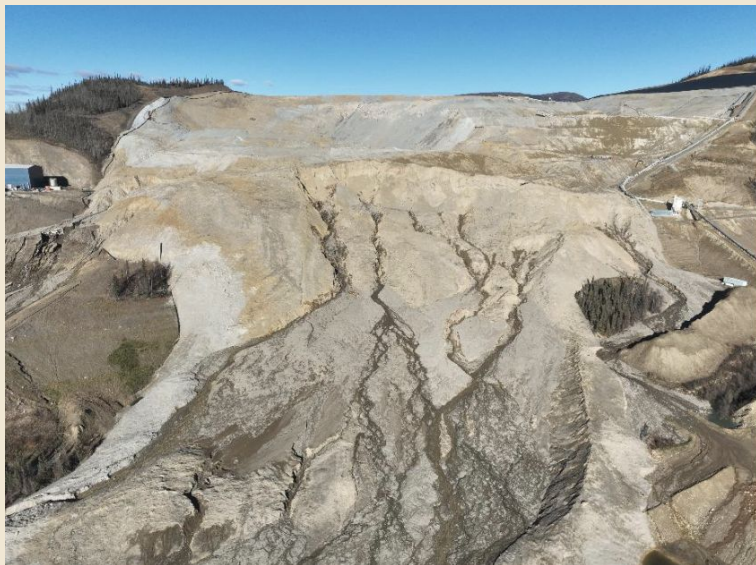
**Heap Leach Facility**  
**Oct 2, 2024**

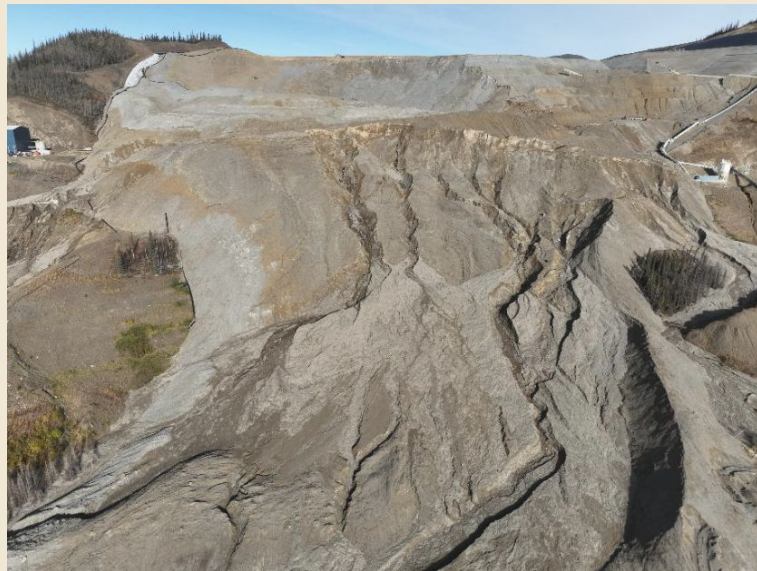
**Heap Leach Facility**  
**Oct 2, 2025**

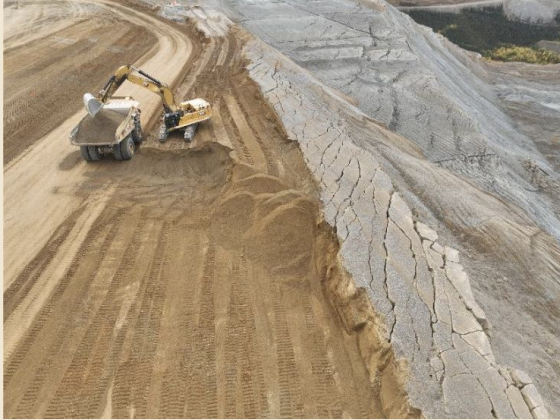
**Excavating material above  
failure scarp, Sept. 15**

- **Phase 1a Remediation – started August 10**
  - Relocate portions of the 1065 bench to reduce load on the upper failure scarp
  - 200,000 m<sup>3</sup> of material relocated to the back of the HLF on existing liner

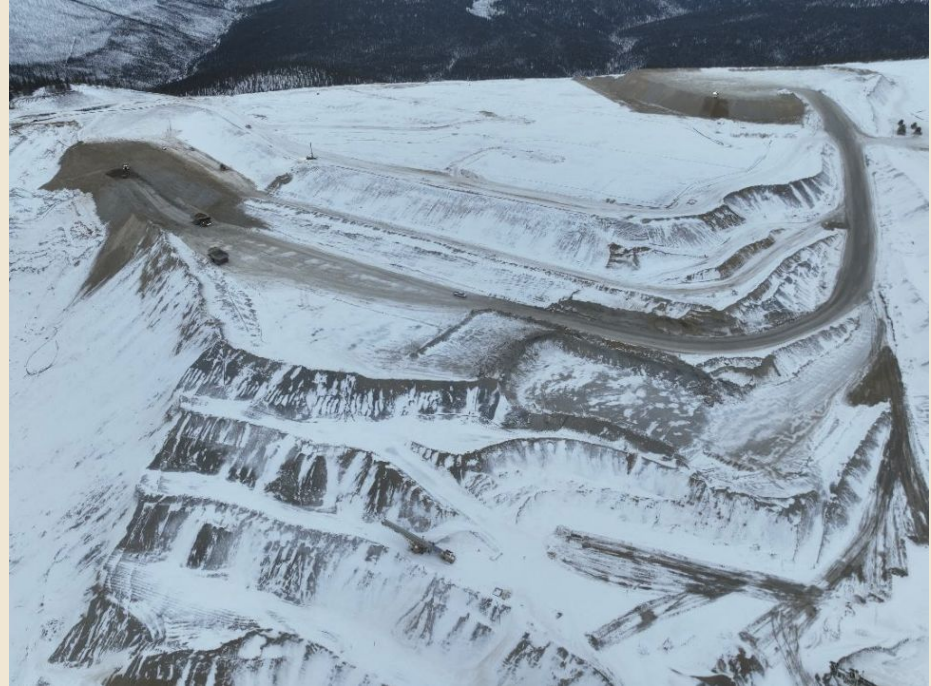
- Improve stability of failure scarp to allow access to failure areas and planning for Phase 2
- 800,000 m<sup>3</sup> of material from benches adjacent to the failure

Relocating ore from above the failure scarp,  
Nov. 9

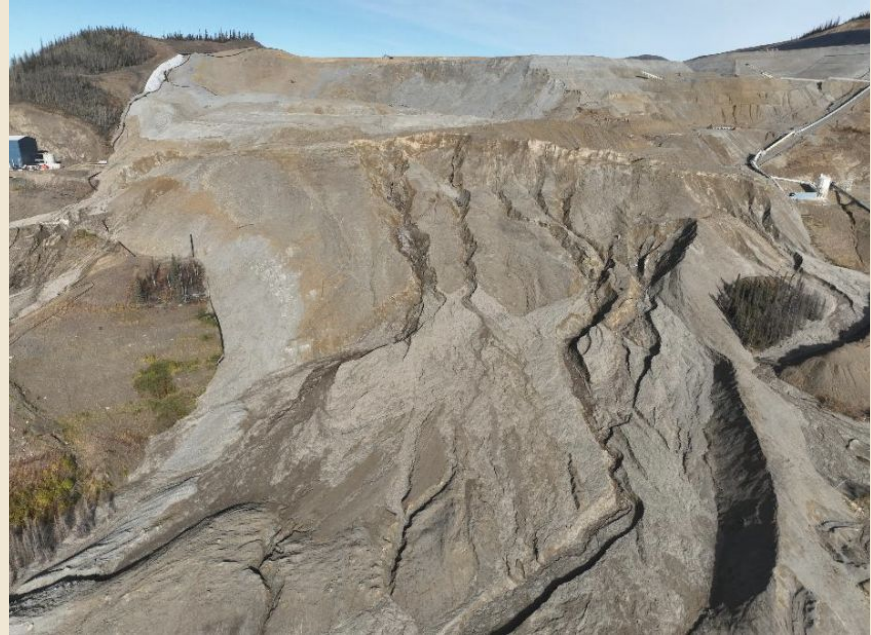
- There has been **no investigation of heap conditions** within the failed zone, including the retaining dam
- Phase 1a and 1b work aimed at creating conditions that will allow further investigation and planning for heap remediation
- Heap remediation will be complex and challenging, and **the work has barely begun**

Heap Leach Facility Oct 2, 2025

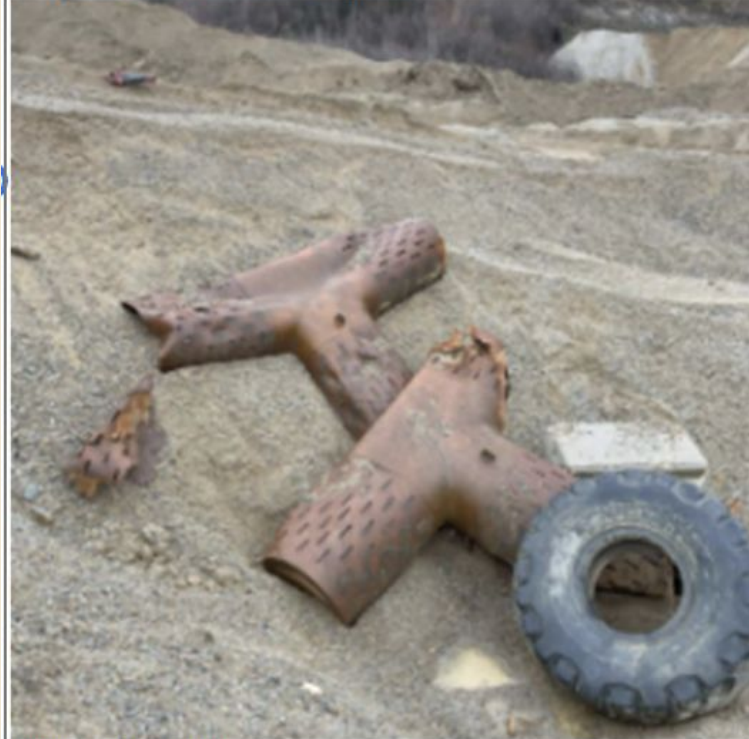
Figure A.1.40: 450-mm screened-steel pump intakes

Note: Base elevation 910.5 m  
Source: VGC

- Independent Review Board and Delve Underground considered condition of the heap, liner and solution collection systems
  - Equipment from the bottom of the In-Heap Pond swept away in the failure
  - Pumping systems destroyed
  - Flawed and sub-standard liner construction and operational practices led to damage of critical liner components (e.g. geosynthetic clay liner) in some locations including outside of areas affected by failure
  - The extent of liner and leach collection system damage caused by the failure is unknown
- Confirming the integrity of liner and leach collection systems, especially in the In-Heap Pond will be a complex and costly undertaking with enormous engineering challenges and, safety and environmental risks to overcome
- There is no precedent or road map for how to do this
- **How and whether the heap can be repaired remains a substantial uncertainty**

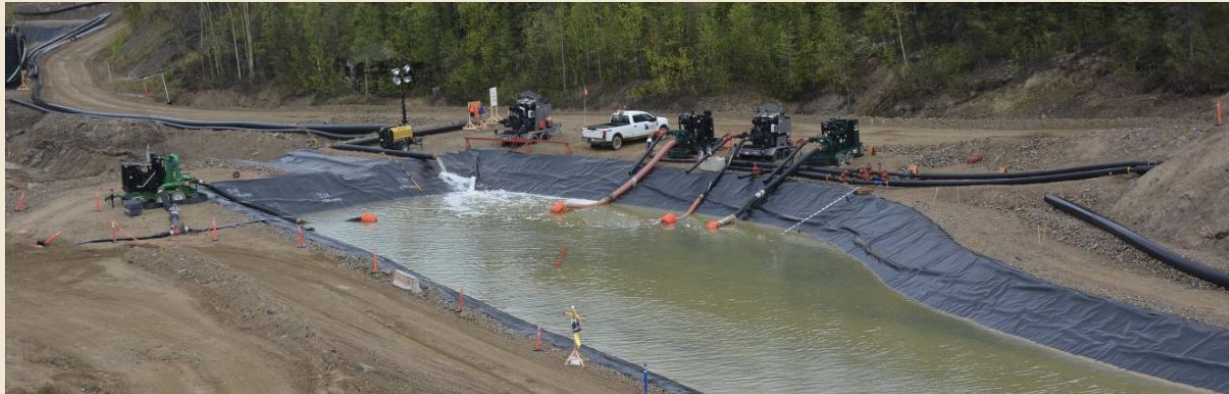
DG2 Sump,  
June 5, 2025

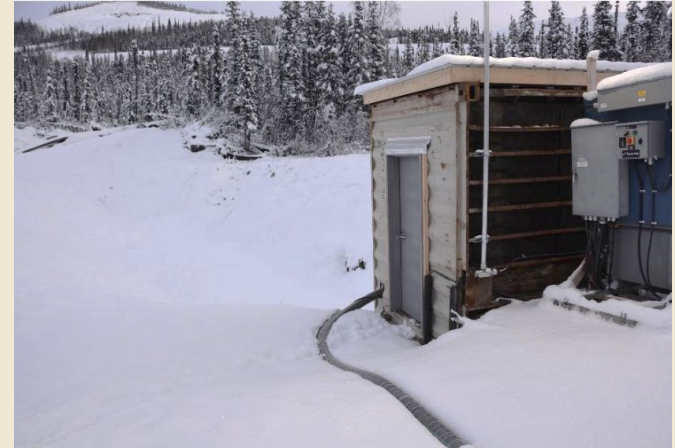
- **Groundwater related effects in Haggart Creek initially observed in September 2024**
- Collection of seepage near Haggart Creek began October 21, 2024
  - W22-Seep 2
- Intermittent collection of groundwater at other locations through winter of 2024
  - Sump DG4, Nov. 16 to Dec. 18, and then beginning on March 5
  - Well MW10-DG7, Jan. 23 to Feb. 5 and then beginning on February 16
- **Groundwater related effects continued to increase through the winter**

DG4 Sump, October 2025

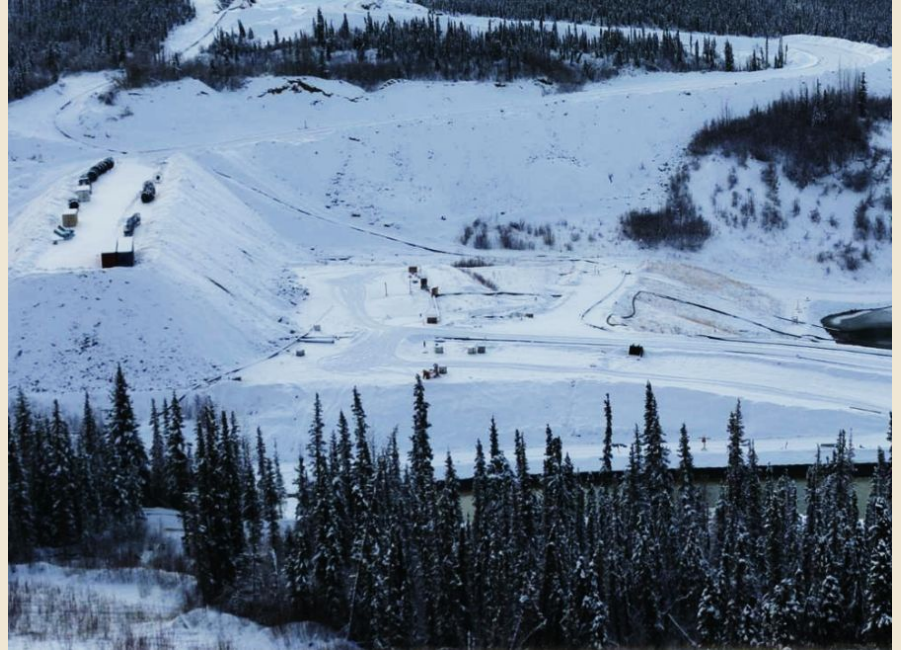
- Systematic groundwater collection:
  - Wells drilled fall 2024
  - Collection in wells downstream of Control Pond – May 20, 2025
  - Collection in wells upstream of Control Pond – May 28, 2025

**Groundwater Wells Upstream of  
Control Pond, October 2025**

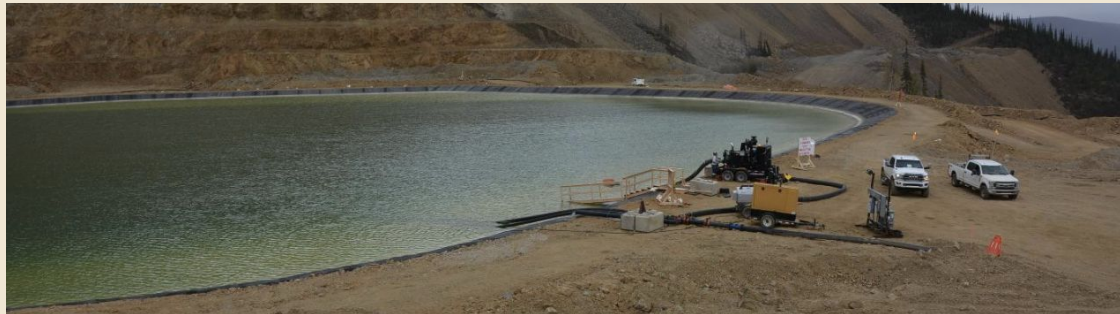
Pit Pond 1/2,  
June 2025

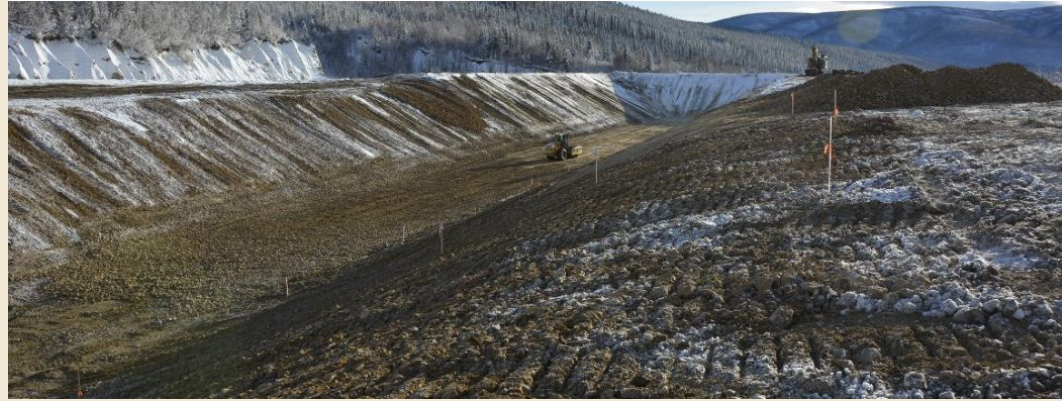
- IROSA Pond 2 identified as leaky in mid-December 2024
- Over 50,000 m<sup>3</sup> of untreated and partially treated cyanide solution was discharged to the environment through the leaky pond between December 2024 and April 2025
- Pond is currently being repaired

Repair of IROSA 2, October 2025

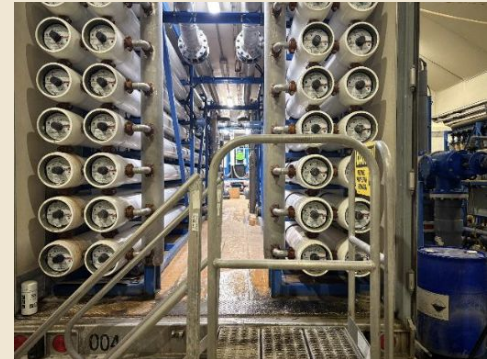
# Cyanide Solution & Water Treatment

- Approximately 1 million m<sup>3</sup> of cyanide-impacted water has been treated to date.
- **The treatment plant effluent remains elevated in copper, nickel, cobalt, and nitrites.**
- The treated water is not acutely toxic but **continues to cause chronic toxicity in Haggart Creek.**
- Water quality in Haggart Creek can be significantly improved for both cobalt and cyanide using a treatment already demonstrated successfully on-site at a smaller scale, pending available funding for implementation.
- **The treatment plant is scheduled to shut down in mid-November.**

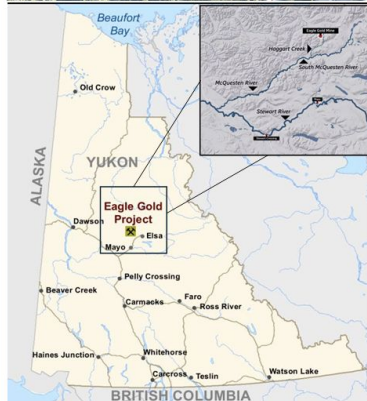
## Introduction-Mining Disaster

**June 2024:** a landslide at Eagle Gold Mine (central Yukon) released millions of liters of toxic cyanide solution into Haggart Creek – upstream of culturally significant spawning grounds for Chinook salmon and on the traditional territory of the FNNND.

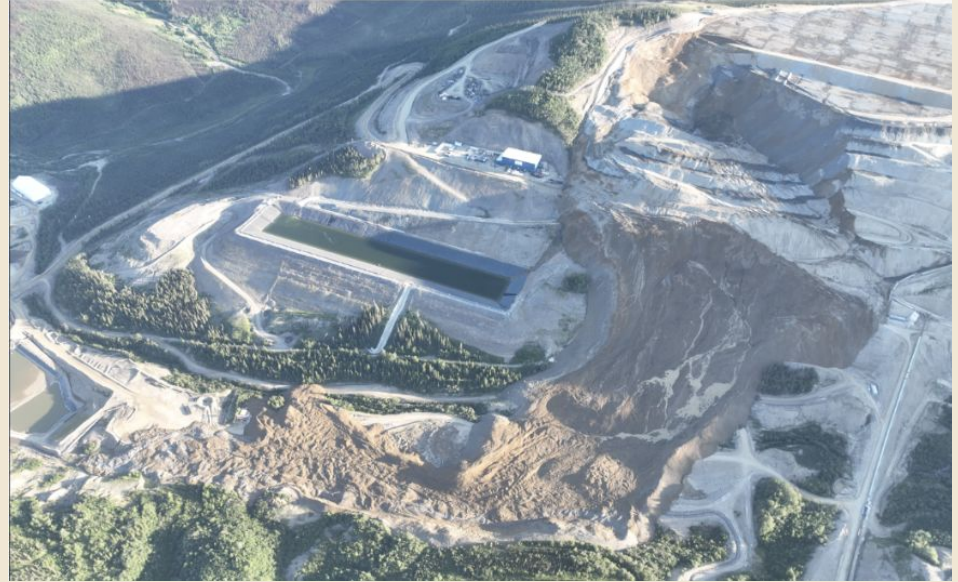
**June 24, 2024. Source: VGC**
